**ENBRIDGE PIPELINES INC. INTEGRITY PROGRAM
PRELIMINARY ASSESSMENT FORM**

NAME:	Jayne Viglas
DATE:	October 9, 2014
REPORT #:	23A – GW 85560

Line: 23A	GW: 85560	MP:	KP:
Project number: 113256715	Latitude: _____ Longitude: _____	UTM <u>14 U</u>	(E): <u>337205</u> (N): <u>5512141</u>

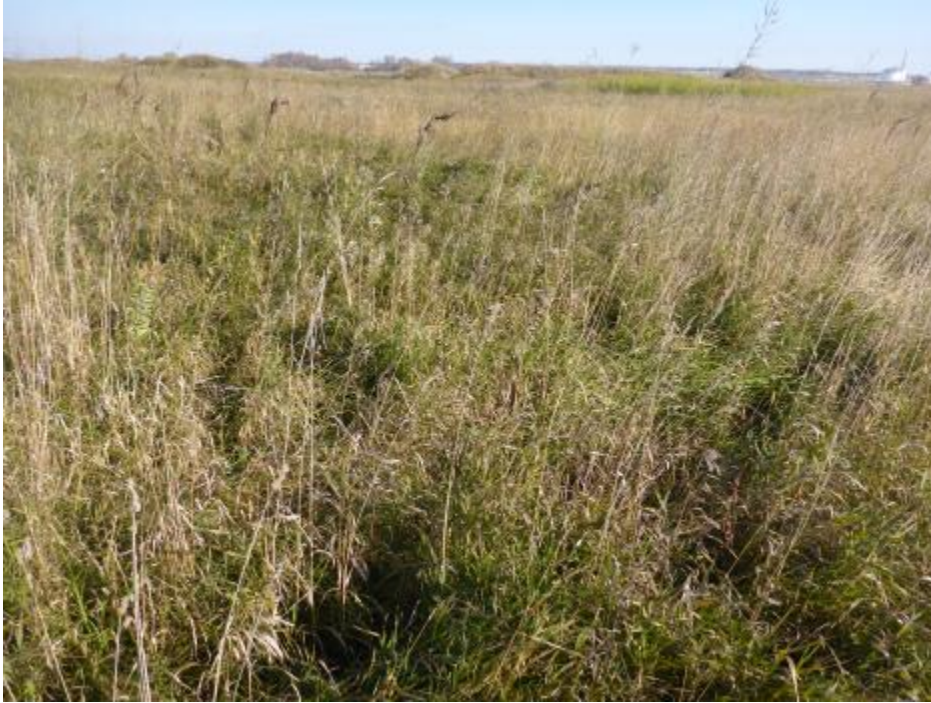
Photo 1: Looking north from the dig site located at SE 18-09-28 W1M.

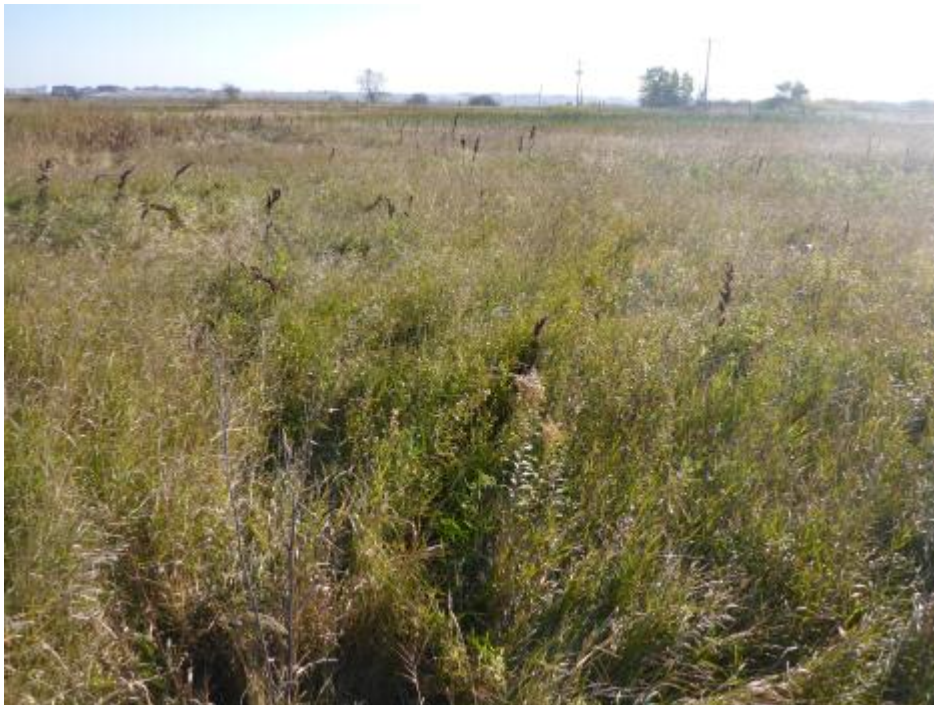
Photo 2: Looking east from the dig site located at SE 18-09-28 W1M.

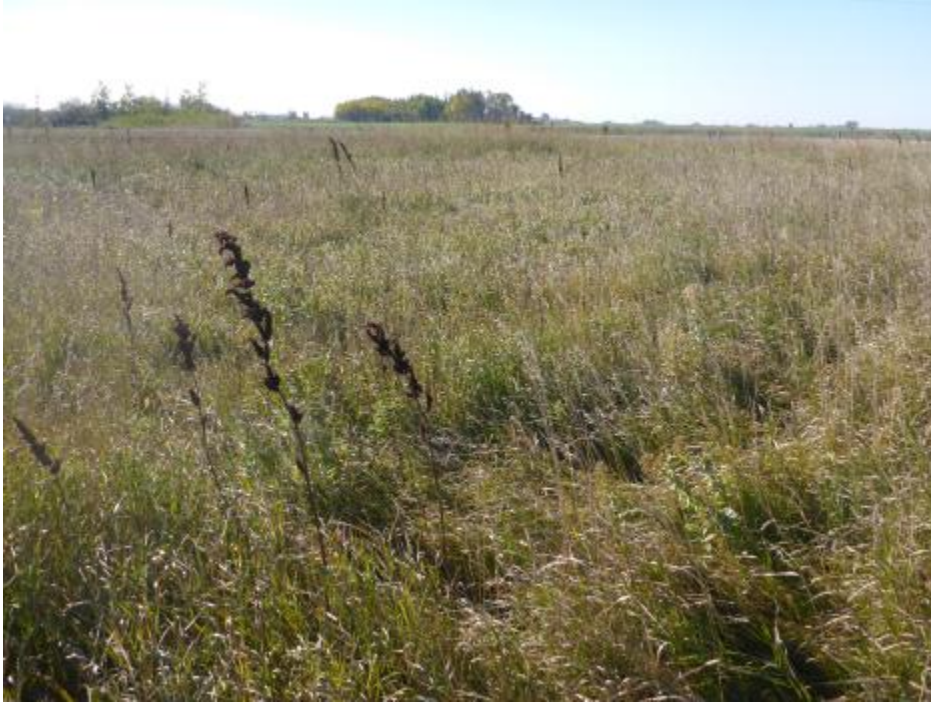
Photo 3: Looking south from the dig site located at SE 18-09-28 W1M.

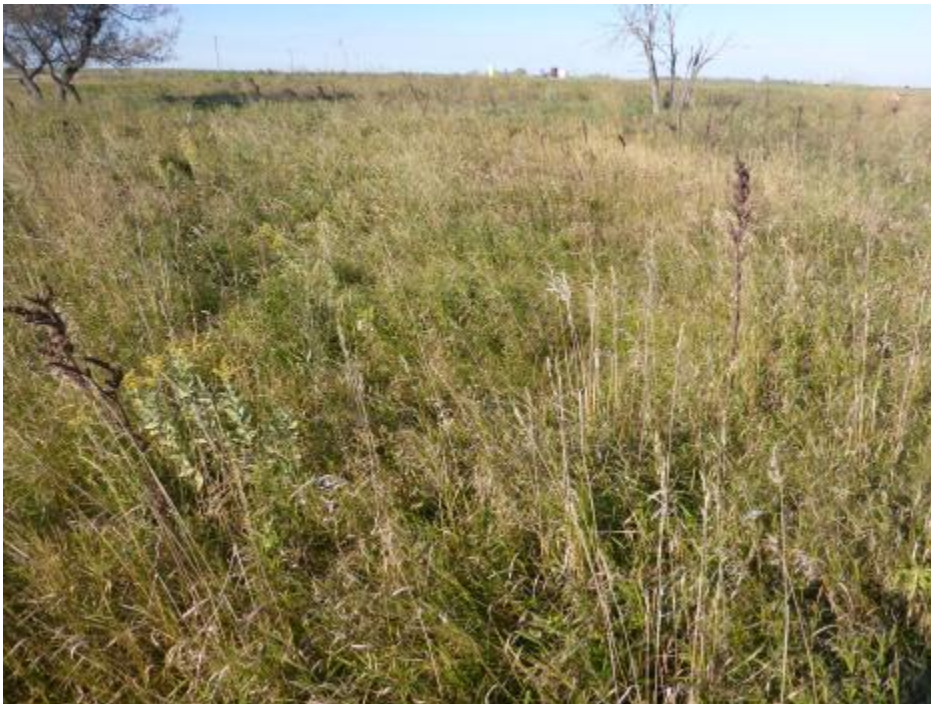
Photo 4: Looking west from the dig site located at SE 18-09-28 W1M.

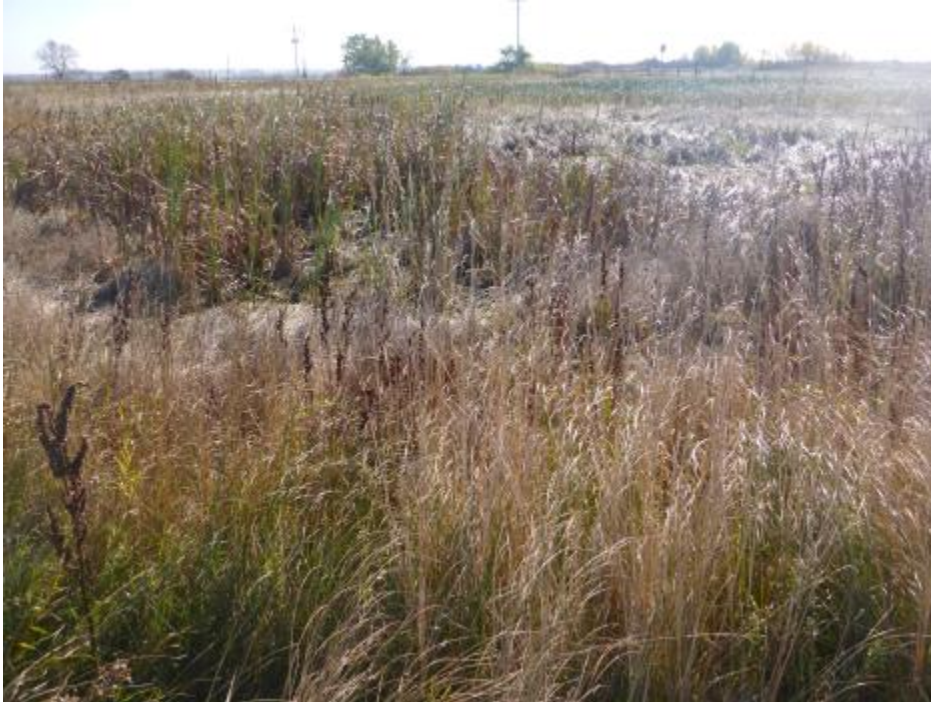
Wetland 1 (14U E: 337196, N: 5512153) – This Class II wetland is located 24 m from the dig site. The dominant vegetation species included narrow-leaved cattail (*Typha angustifolia*), curled dock (*Rumex crispus*), water smartweed (*Polygonum amphibium*), foxtail barley (*Hordeum jubatum*), reed canary grass and slough grass (*Beckmannia syzigachne*).

Distance: 24 m

Photo 5: View of Wetland 1 at SE 18-09-28 W1M.

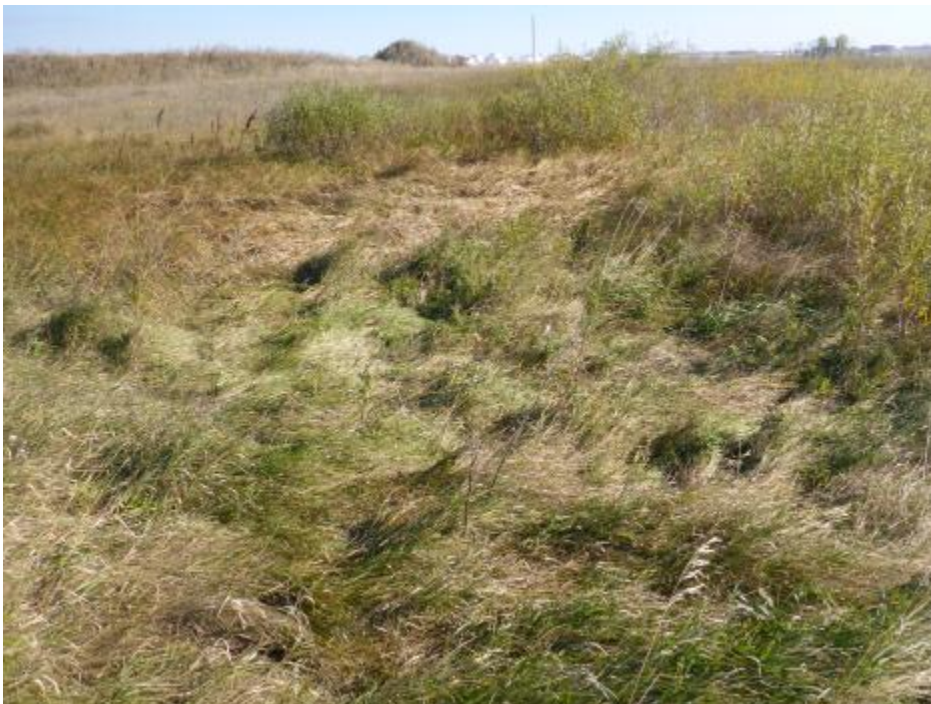
Wetland 2 (14U E: 337185, N: 5512210) – This wetland is located 71 m from the dig site. Dominant vegetation species included willow species (*Salix spp.*), smooth brome, curled dock and western snowberry (*Symphoricarpos occidentalis*).

Photo 6: View of Wetland 2 at SE 18-09-28 W1M.

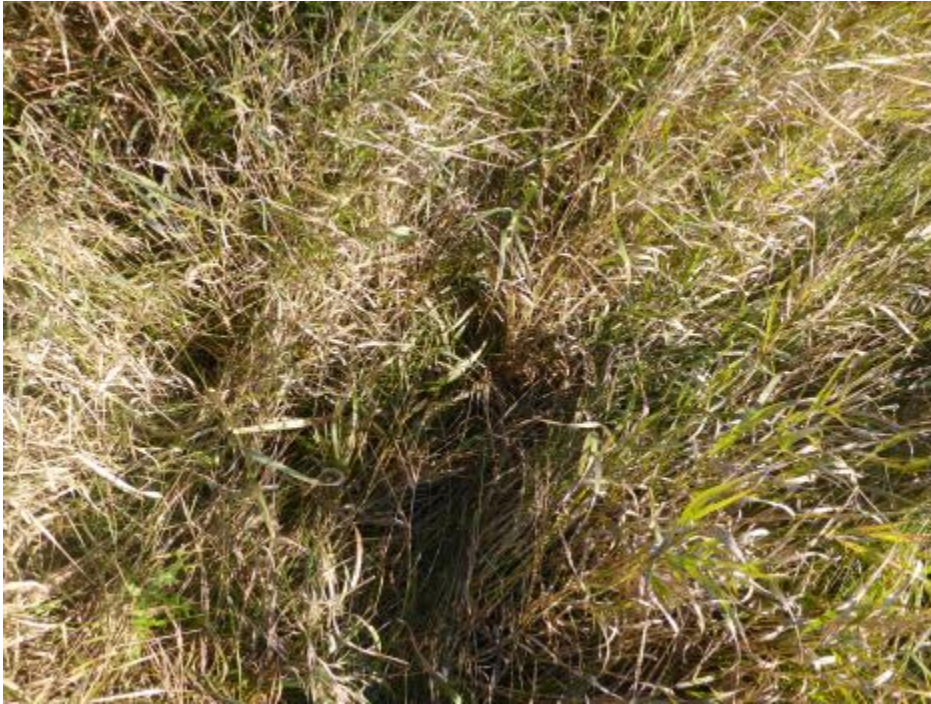
23A85560-1 (14U E: 337177, 5512139) – This sample was taken on the right-of-way from within the dig site at SE 18-09-28 W1M.

Photo 7: View of the representative ground cover at clubroot sampling location 23A85560-1. This sample was taken within the dig site at SE 18-09-28 W1M.

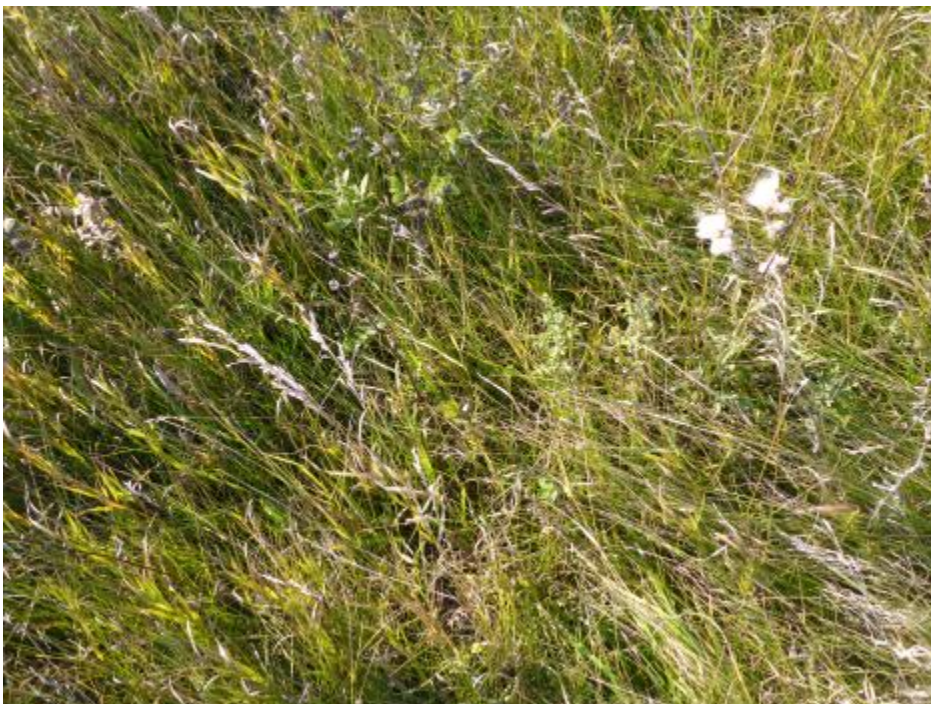
23A85560-2 (14U E: 337246, 5512209) – This sample was taken off of the right-of-way on the access route at SE 18-09-28 W1M.

Photo 8: View of the representative ground cover at clubroot sampling location 23A85560-2. This sample was taken within the existing right-of-way along the access route at SE 18-09-28 W1M.
