Re: Westcoast Energy Inc., carrying on business as Spectra Energy Transmission ("Westcoast")
Transmission North 2012 Expansion Project
Order XG-W102-005-2012, Condition 7
Third Year Post Construction Environmental Monitoring Report
National Energy Board File: OF-Fac-Gas-W102-2011-05 01

**THIRD YEAR POST-CONSTRUCTION ENVIRONMENTAL
MONITORING REPORT
FOR THE
WESTCOAST ENERGY INC.
T-NORTH 2012 EXPANSION PROJECT**

January 2016

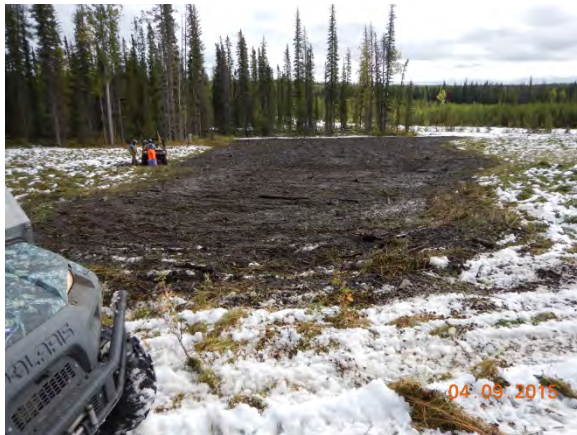
Photo 1. Ground crew using light equipment to harrow, seed and apply fertilizer at KP 0.250 (September 4, 2015).

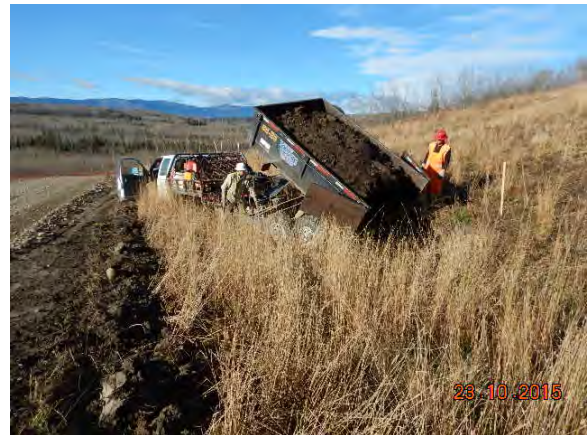
Photo 2. Ground crew in the process of filling the minor bellhole subsidence at KP 2.570 prior to packing, seeding and applying fertilizer (October 23, 2015).

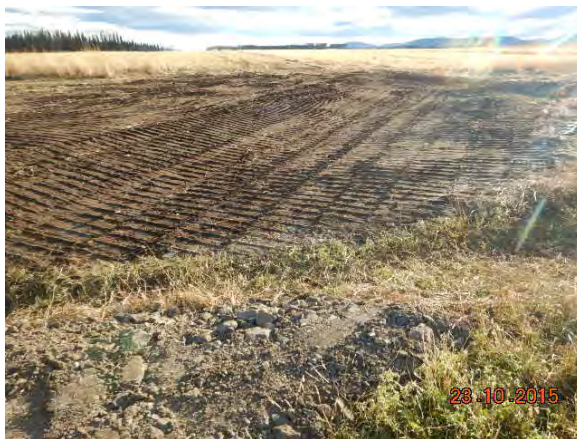
Photo 3. Repairs underway at KP 4.060 to correct drainage issues caused by recent clean-up on an adjacent line and landowner water management practices (October 23, 2015).

KP 4.050 to KP 4.070	Road Allowance	Erosion	Adjacent pipeline cleanup and landowner activity did not tie surface flows into the established drainage across the ROW causing erosion channeling adjacent to the drainage.	Repair erosion gullies, reshape and armor drainage, install topsoil adjacent to the drainage, install erosion control matting, in the drainage, seed and fertilize (Photo 3 in Section 5.2)	Resolved
KP 4.070 to KP 5.300	Pasture/ Forested	Erosion	Landowner seeding was completed and has established. The drainage / wet site between KP 4.646 and KP 4.749 has stabilized and is well vegetated. There were three locations across this quarter with rill or minor gully erosion on the ROW. Although the landowner was not concerned the sites were repaired to avoid further issues.	Repair erosion, seed and fertilize	Resolved
KP 5.300 to KP 7.350	Pasture/ Forested	No issues observed	Vegetative cover is well established throughout this section and no other concerns were noted.	No action required	Resolved

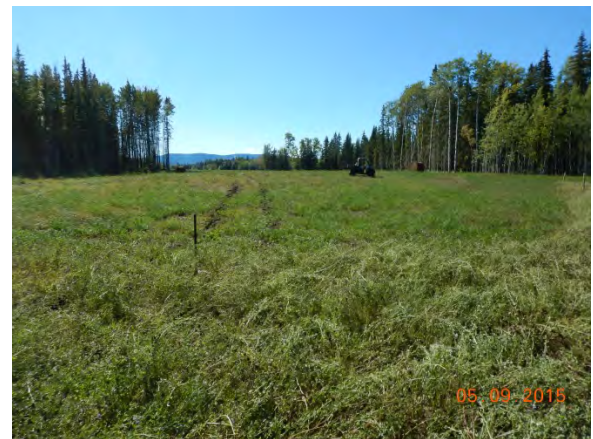
Photo 4. Repair of landowner caused rutting leading to the break in slope at Lynx Creek to eliminate water channeling and the potential for erosion (September 5, 2015).

Location (KP)	Land Use	Issue(s)	Observations Noted	Corrective Actions Recommended	Status
KP 7.350 TO KP 7.730	Lynx Creek	No issues observed	Armoring, bed, flood channel and banks are stable on Lynx Creek at KP 7.520. The riparian zone is well vegetated and the surface breakers are stable and functioning as required. Survival of the planted stock (e.g. willow and spruce, etc.) is adequate considering the extensive vegetative cover.	No action required	Resolved
KP 7.730 to KP 8.150	Forested	Vegetation	The new landowner has decided to hay the ROW through this previously forested area. Vegetation establishment is progressing well however less than optimal for the production of hay. The landowner requested further work be completed to enhance vegetative cover. It should also be noted that due to the cutting of hay all planted tree stock above the break in slope south of Lynx Creek has now been removed.	Over seed with a pasture mix (as per specific landowner request) and fertilize. Also landowner caused rutting was corrected above the break in slope at Lynx Creek to eliminate water channeling and the potential for erosion (Photo 4 in Section 5.2).	Resolved

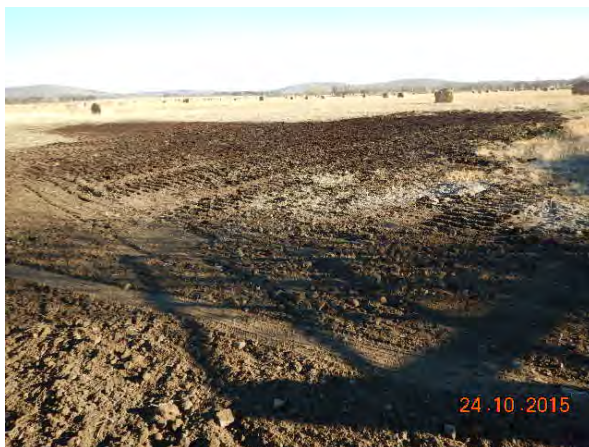
Photo 5. Work completed to re-establish grade, install topsoil, track pack and seed to repair livestock damage at KP 9.050 (October 24, 2015).

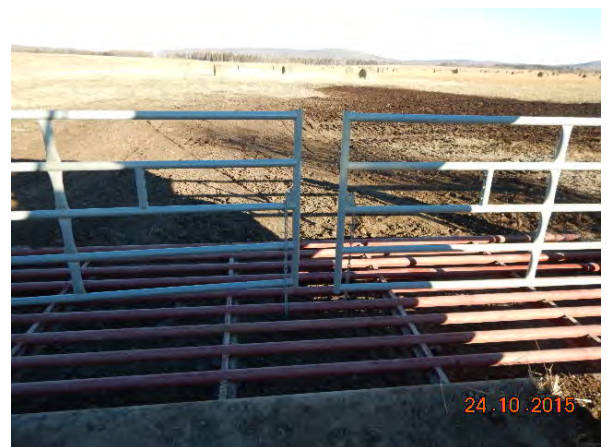
Photo 6. Work completed to re-establish grade, install topsoil, track pack and seed to repair livestock damage at KP 9.150 (October 24, 2015).

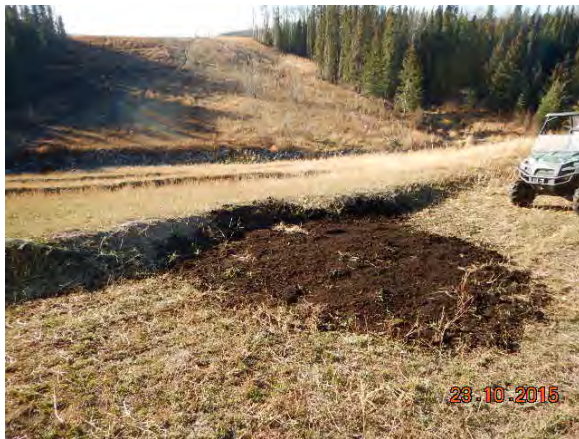
Photo 7. Topsoil placed for packing and seeding to repair the surface breaker and compaction / water ponding caused by livestock overuse on the north slope of Brenot Creek at KP 12.710 (October 23, 2015).

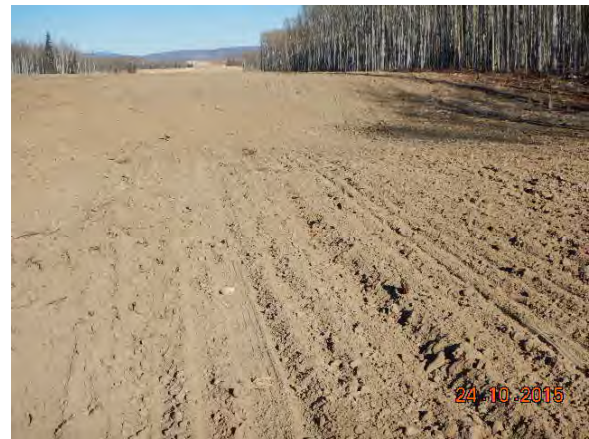
Photo 8. Looking north from KP 14+750 at the disking and seeding completed by the landowner to address overuse by livestock and the lack of seeding after clean-up (as had been committed by the landowner) (October 24, 2015).

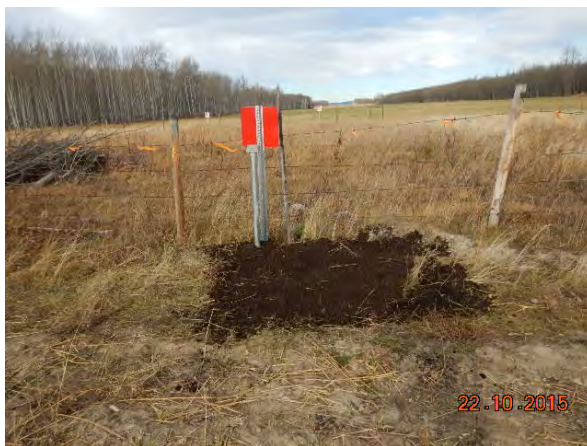
Photo 9. Added topsoil, packed and seeded minor subsidence just west of the T-North 2012 ROW as per the landowners request (October 22, 2015)..

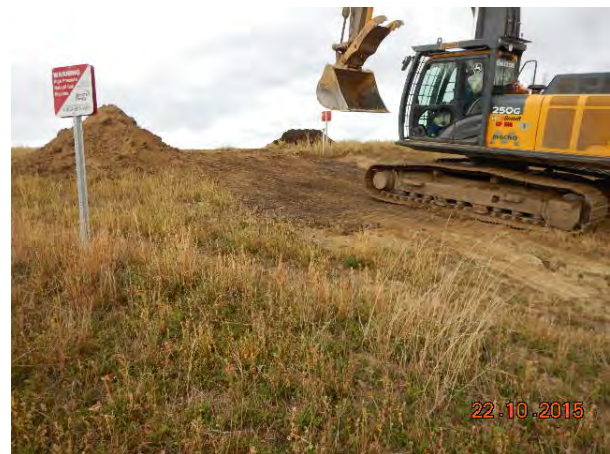
Photo 10. Topsoil was stripped and the erosion gullies on the slope at KP 17.920 were filled with shale and compacted to prevent further erosion (October 22, 2015).

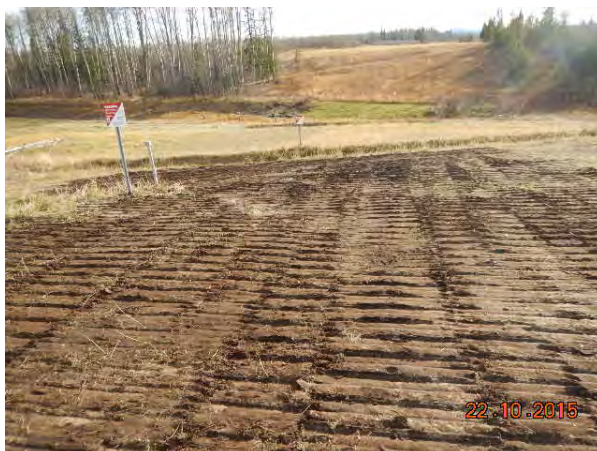
Photo 11. Topsoil was then replaced and seeding and track packing was completed at KP 17.920 (October 22, 2015).

Also note the landowner clearing that has taken place on the banks of Portage Creek in the area that had been purposefully left undisturbed during construction.

KP 14.850 to KP 16.340	Forested / Pasture	No issues observed	Crop density and vigor as well as plant color (on all newly cultivated areas) was very good across the remainder of this property. No other concerns were noted.	No action required	Resolved
KP 16.340 to KP 17.895	Forested / Cultivated	No issues observed	The entire area is now under cultivation. Crop density and vigor were good (considering the transition from forest land). The landowner did ask us to fill in around two posts just off and to the side of the ROW.	Added topsoil, packed and seeded minor subsidence at two locations just west of the T-North 2012 Project ROW as per the landowners request (Photo 9 in Section 5.2). Otherwise, no action required.	Resolved
KP 17.895 to KP 17.950	Forested	Erosion	The bed and banks are stable on Portage Creek at KP 17.960. The riparian zone is vegetated and the surface breakers are stable and functioning as required. The planted willows are doing well although the landowner has been removing them to avoid interference with landowner's horses. Minor rutting on the upper slope (caused by third party workers) between the access road and the surface breaker had resulted in the development of several erosion gullies.	Shape up and compact the erosion gullies. Fill the erosion gullies with shale material and compact (Photo 10 in Section 5.2). Apply topsoil over the disturbed area, seed and track pack (Photo 11 in Section 5.2).	Resolved

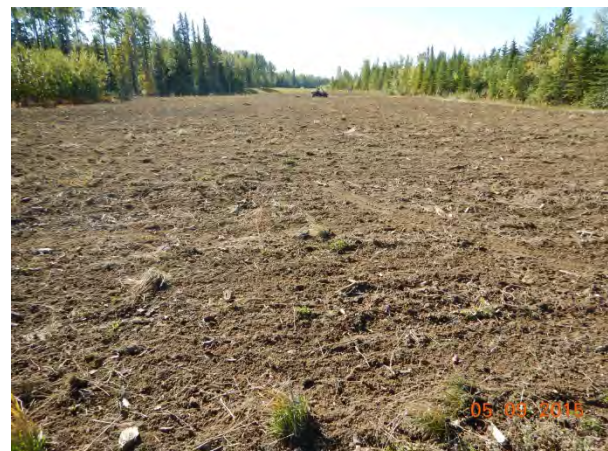
Photo 12. Looking south from KP 18.550 at the disking completed by the landowner and seeding completed by the contractor to address erosion and the lack of vegetation as a results of seeding not being completed by the landowner as committed (September 5, 2015)

KP 17.950 to KP 18.510	Cultivated	No issues observed	The entire area is now under cultivation. Crop density and vigor as well as plant color was very good and no other concerns were noted.	No action required	Resolved
KP 18.510 to 18.660	Forested	Erosion / Vegetation	The landowner had not seeded as committed. As a result vegetation establishment was poor (well below the required standard) and rill and minor gully erosion was present.	We worked with the landowner who disked and levelled the ROW to the top of the bank. We then completed seeding (a pasture mix), fertilizer application and harrowing (Photo 12 in Section 5.2).	Resolved

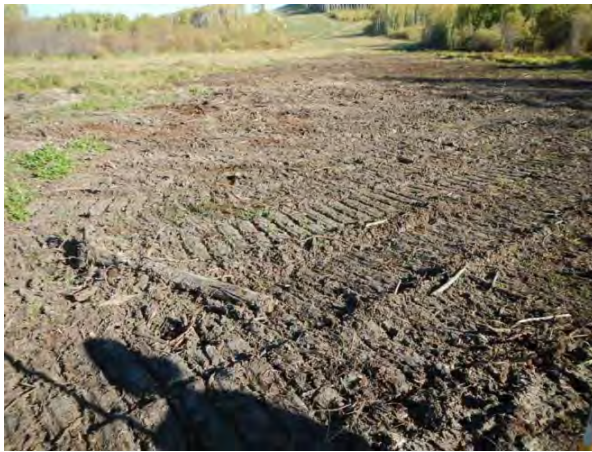
Photo 13. View north along the right-of-way of limited vegetation establishment on private land at KP 3.044 (September 11, 2013).

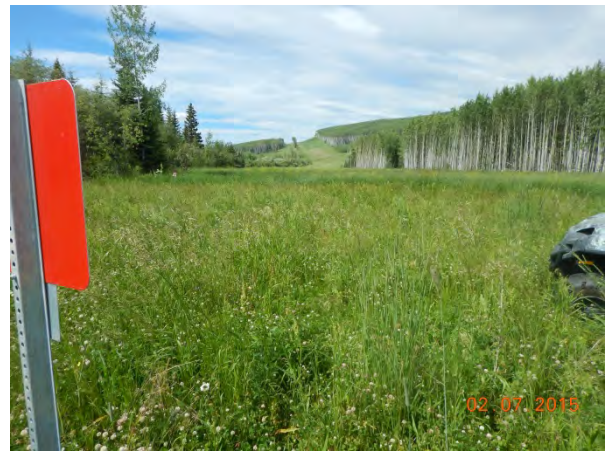
Photo 13a. Same general view as Photo 1 showing extensive vegetation and coverage after re-treatment, the landowner had not met his commitment to seed (July 2, 2015).

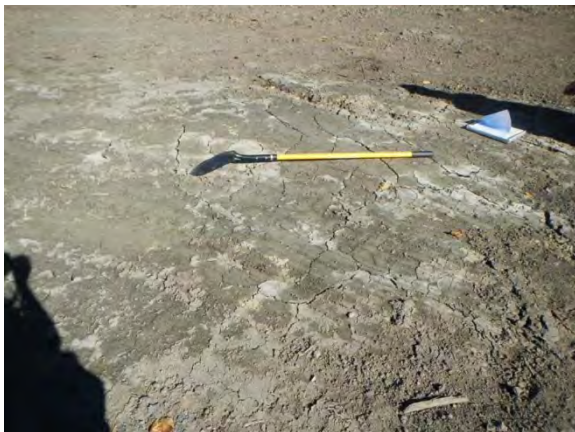
Photo 14. View of right-of-way and subsoil within an area described as wet and marshy during the pre-construction survey at KP 4.749 (September 11, 2013).

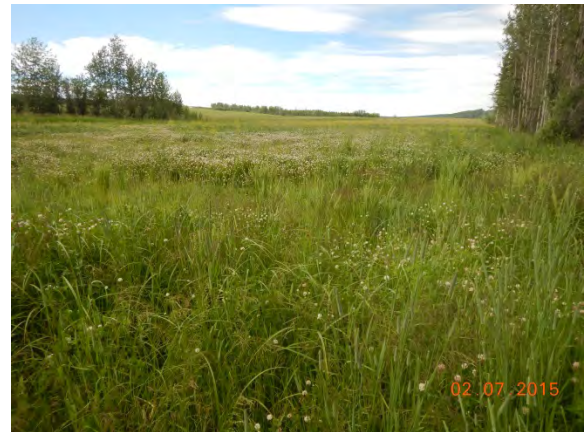
Photo 14a. View of the same area as Photo 14 showing extensive vegetation and full coverage throughout the nutrient rich marshy area (July 2, 2015).

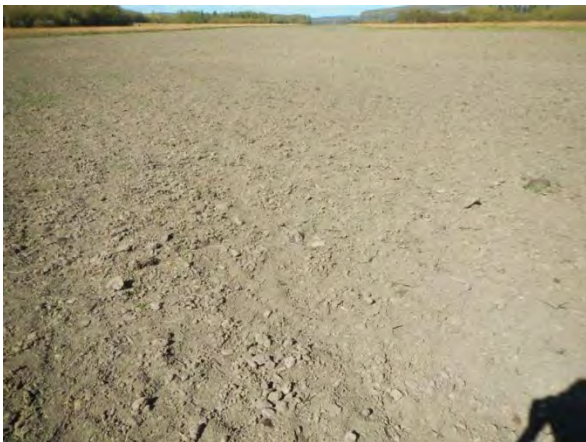
Photo 15. View north along the right-of-way of limited vegetation establishment on unseeded, private land at KP 7.037 (September 11, 2013).

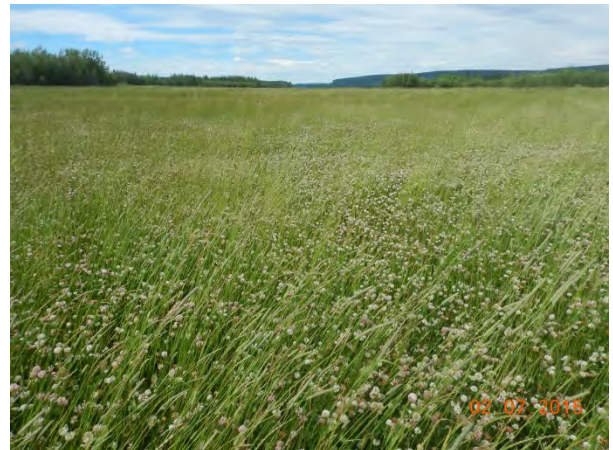
Photo 15a. Same view as Photo 15 showing extensive vegetative growth and coverage with good diversity of species. This site had been seeded when Photo 15 was taken (July 2, 2015).

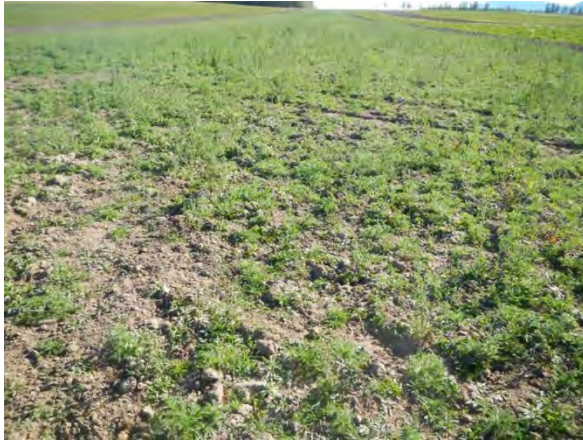
Photo 16. View south of the right-of-way and weeds at KP 10.094 (September 10, 2013).

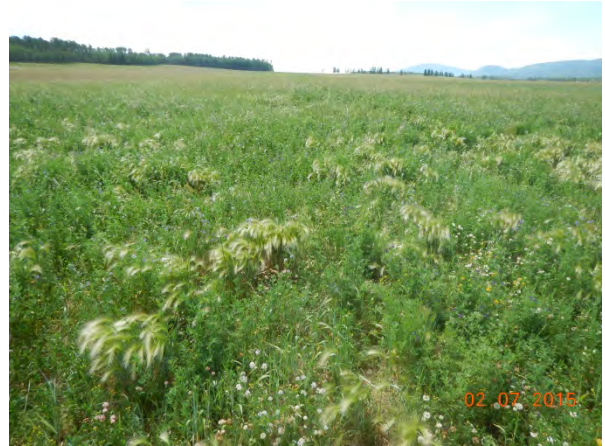
Photo 16a. Same general view as Photo 16 showing extensive vegetation and coverage across the entire pasture (July 2, 2015).

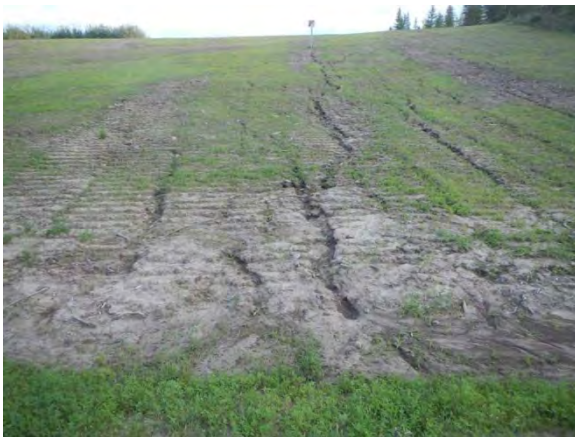
Photo 17. View south of the right-of-way and rill erosion on the south approach slope to Portage Creek at KP 17.958 (August 28, 2013).

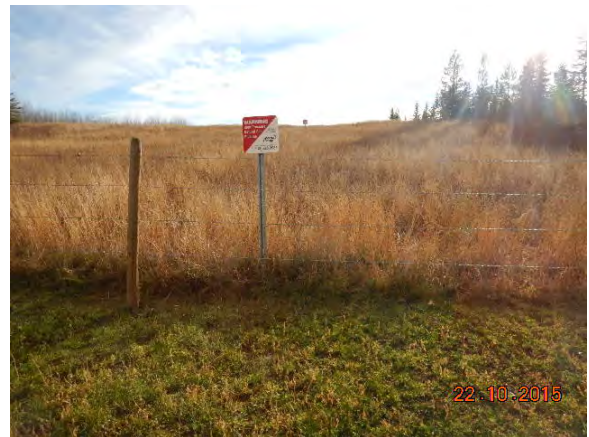
Photo 17a. Same view as Photo 17 showing extensive vegetation and full coverage on the slope which is now stabilized with little to no visible evidence of erosion (October 22, 2015).

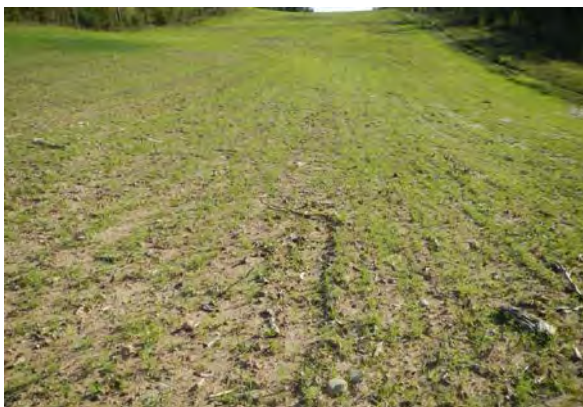
Photo 18. View south of the right-of-way and emerging vegetation following seeding at KP 21.610 (September 9, 2013).

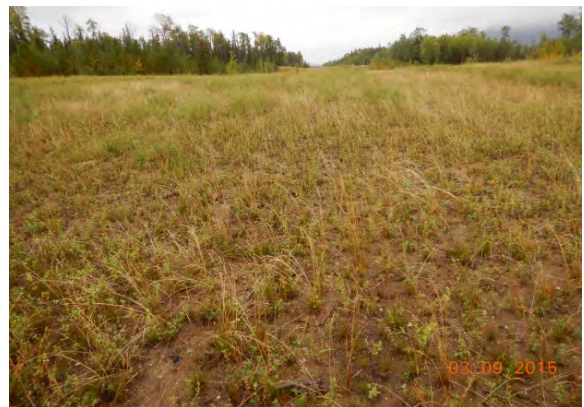
Photo 18a. View of the same general area as Photo 18 showing generally low vegetative cover on the sandy well drained nutrient poor soils. This issue was noted in Table 1 and corrective actions were implemented (September 3, 2015).

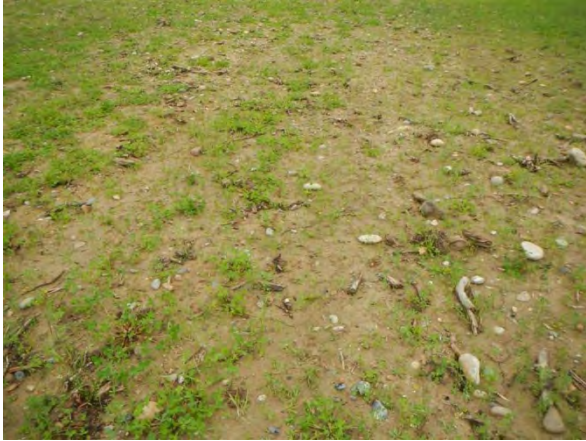
Photo 19. View of the right-of-way and establishing clover vegetation at KP 23.902 (**August 27, 2013**).

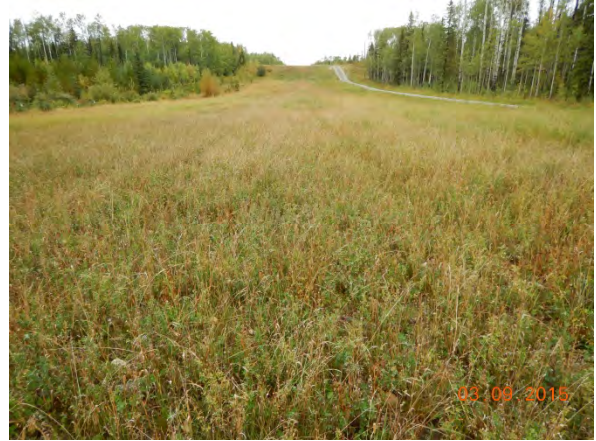
Photo 19a. View from the same area as Photo 19 showing good vegetation including diversity of species and coverage (**September 3, 2015**).

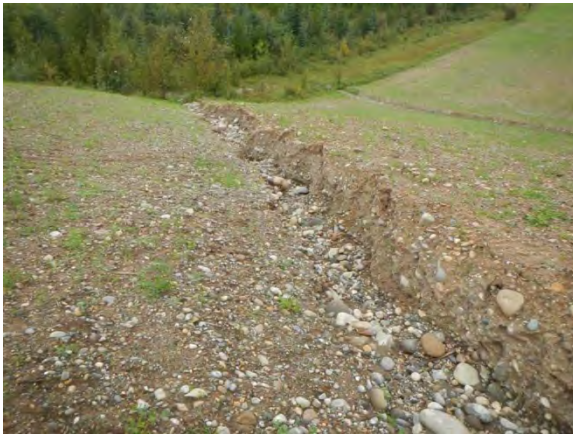
Photo 20. View northwest across the right-of-way and gully erosion along a diversion berm (**August 27, 2013**).

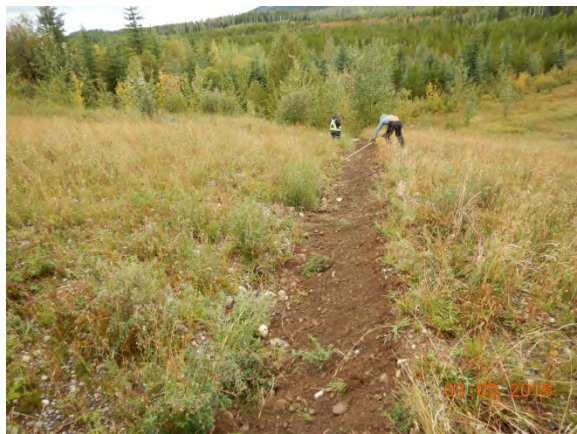
Photo 20a. Same general view as Photo 20 showing good vegetation and coverage on the slope and repairs to the diversion berm (**September 3, 2015**).

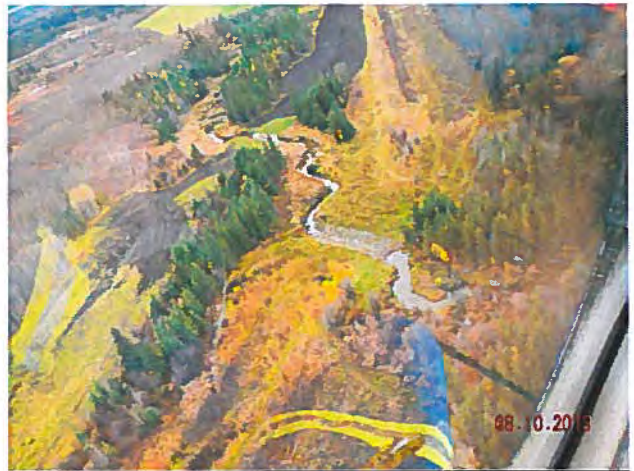
~KP 3.3 WC 3 - Mackie Creek

- Beaver dam present upstream from watercourse crossing, which reduces water flow and creates a barrier for fish passage.
- Vegetation is well established in disturbed areas affected by O&M activities conducted in 2011/12 on the 30" & 36" RoWs.
- Vegetation is well established in riparian areas of the 42" RoW, and vegetation establishing along this RoW to the north and south of the crossing. Westcoast representatives explained that riparian area had been seeded in 2012 during machine clean-up.
- Channel bed and banks of all RoWs through crossings of this watercourse are rock armoured.
- Pipeline identification signage present on both sides of all crossings.

Mackie Creek, looking south. 42" (left), 36" & 30" RoWs (right).

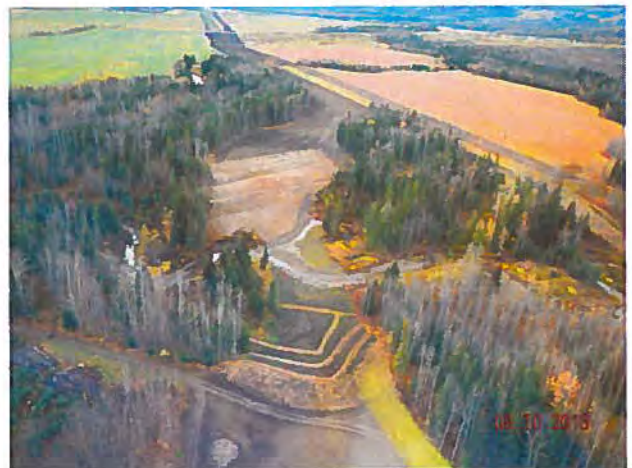
~KP 7.5 WC 4 - Lynx Creek (42" RoW)

- Entire northern and northern and southern slopes planted with plugs of conifer species (White Spruce & Lodgepole Pine) as well as some deciduous species (*Populus spp.* & *Salix spp.*).

- Woody species are appropriately located for their species-specific requirement and adequately spaced. Westcoast also explained that an effort was made to plant woody tree species along the slop to ensure

Lynx Creek (42" RoW), looking south

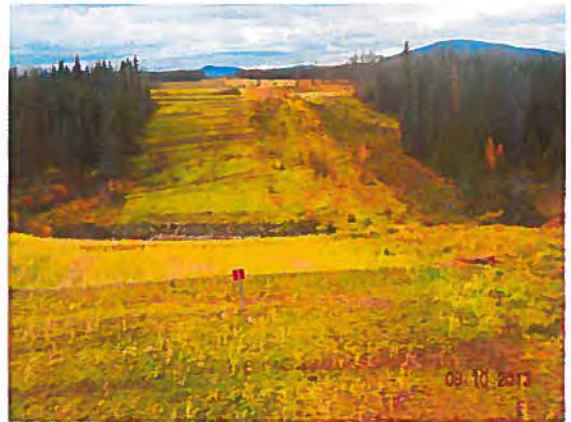
- Westcoast representatives indicated that post-construction reclamation activities for the T-North RoW were completed in July 2013.
- Vegetation was well established in this area dominated by Fall Rye.
- Channel bed and banks were rock armoured. Rip-rap is stable and appropriate for the watercourse.
- Permanent erosion control measures were in place and appropriated on both slope approaches to the watercourse.

Brenot Creek (looking south) – left to right (42", 36", and 30" RoWs)
