**Spectra Energy Midstream Canada Partner Corporation, as general partner for Spectra Energy Midstream Canada L.P. (SEMC) Application for Approval to Reactivate the Pesh Creek Pipeline and Pesh Creek Loop (Pipelines) pursuant to section 45 of the National Energy Board Onshore Pipeline Regulations (Reactivation Application)**

**NEB File No.: OF-Fac-Gas-S383-2016-01**

**Response to Information Request No. 2**

**2.1 Coating condition and external corrosion**

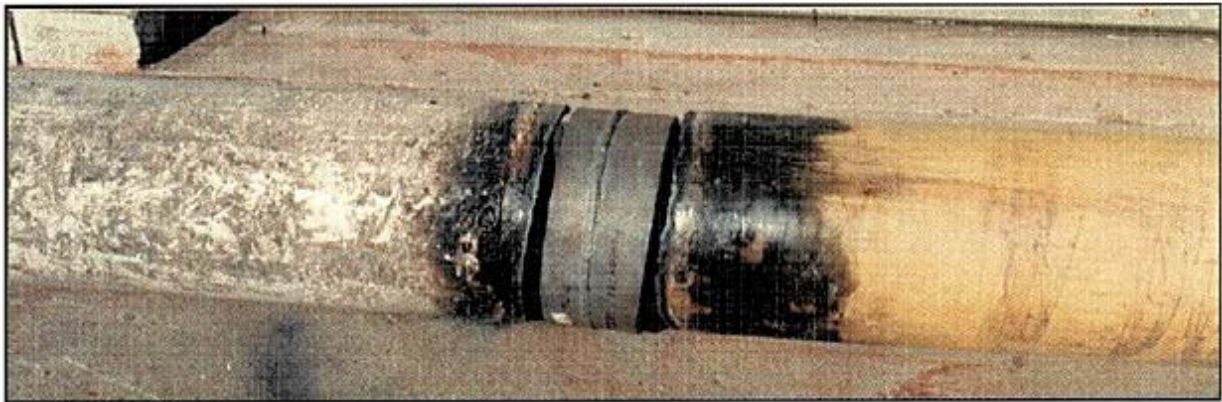
The ability for high temperatures to damage the external coating on a pipeline is limited to the service fluid temperature that is passing through the pipeline. Operational upsets may result in temperatures exceeding the threshold of the external coating. There have been no recorded upsets at the Peggo facility resulting in gas exceeding this temperature limit since the 1998 temperature excursion. As the Pesh Creek Loop Pipeline was built in 2005, the likelihood of external coating damage due to a temperature excursion has been assessed to be very low. The Pesh Creek Pipeline experienced a temperature excursion in 1998 but the gas would have cooled once below ground and, without any further inputs along the pipeline, the temperature of the gas would have continued to decrease along the length of the pipeline. The repair conducted on the Pesh Creek Pipeline after the temperature excursion consisted of excavating the pipeline from the inlet riser until well-bonded coating was found, which would be an indicator that the gas temperature had decreased below the maximum allowable temperature. Figure 1 shows the connection where the pipe with the damaged coating was replaced with new pipe (yellow-jacket) and the original pipeline coating (white-jacket) was kept. This figure shows the original pipe body coating at this connection to be in good condition and adhered to the pipe wall (the shrink sleeve over the weld was removed for analysis). This picture was obtained as part of the failure analysis from the hot-cracking failure that occurred in 1999. Once the temperature had decreased beyond this value, the remaining external coating has

been assessed to have a low likelihood of failure leading to external corrosion as there are no other factors that would have impacted the integrity of the coating.

Figure 1: External coating condition of original pipe (white-jacket) at point of repair from temperature excursion failure.

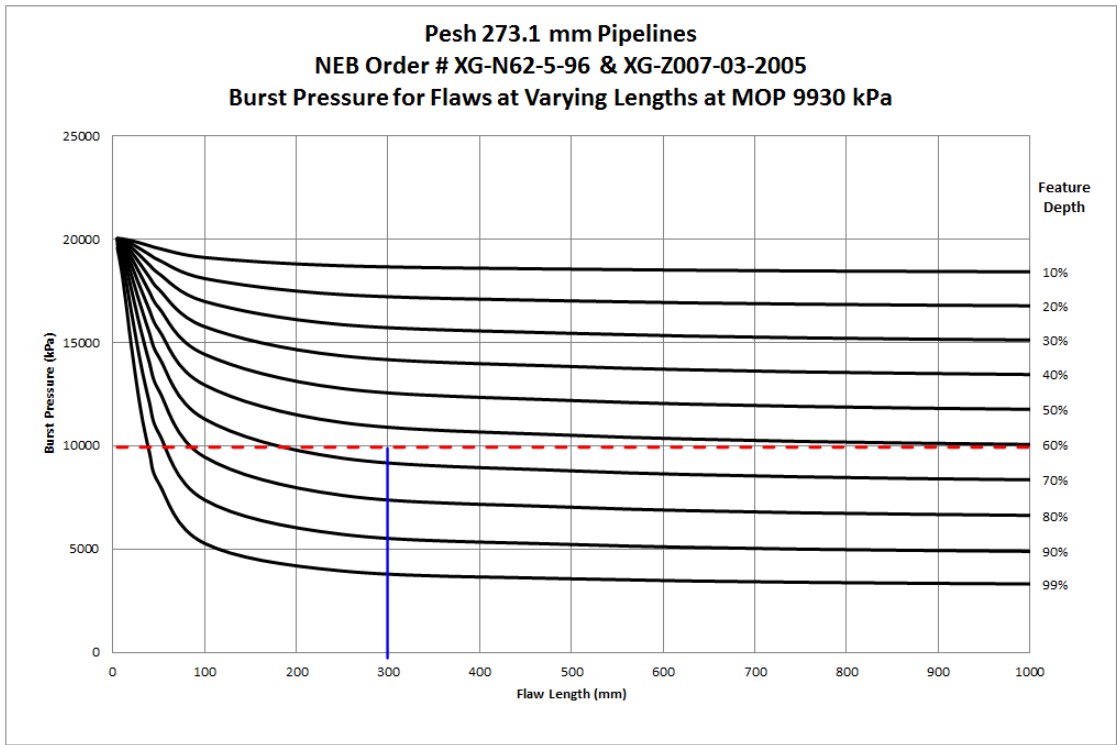
Of note, CNR has also evaluated the Pipelines for gross external wall loss. Based on typical girth-weld exposure areas, in the event that the girth-weld coating system has failed and is shielding the pipe from cathodic protection, the following Modified B31G assessment indicates that the pipeline would require ~65% wall loss over the entire (~300 mm) girth-weld area to cause rupture (see Figure 2). Based on this assessment, there is a low likelihood of failure due to pipeline rupture.

Figure 2: Modified B31G calculation assuming failed coating on girth weld
