## **Photoplates**

### MURPHY OIL COMPANY LTD. TUPPER PIPELINE THIRD YEAR POST CONSTRUCTION MONITORING

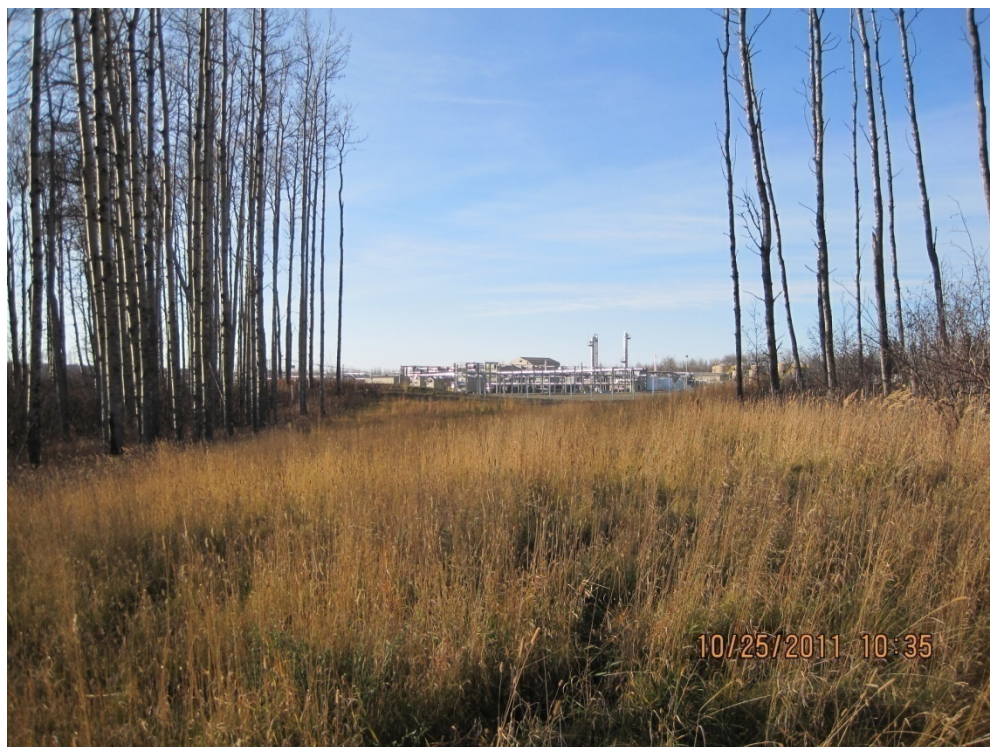
*Photograph 1: Looking southwest along the ROW from chainage 0+050 showing increased vegetation growth since the 2010 PCMP assessment.*

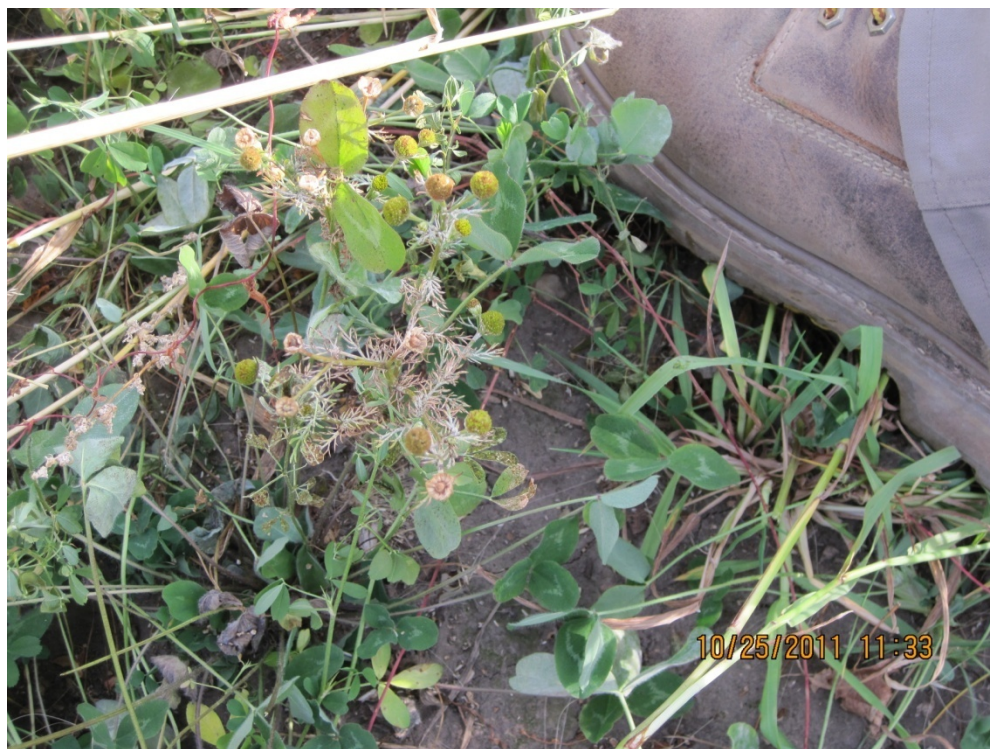
*Photograph 2: Scentless chamomile identified between chainages 1+250 and 1+330*

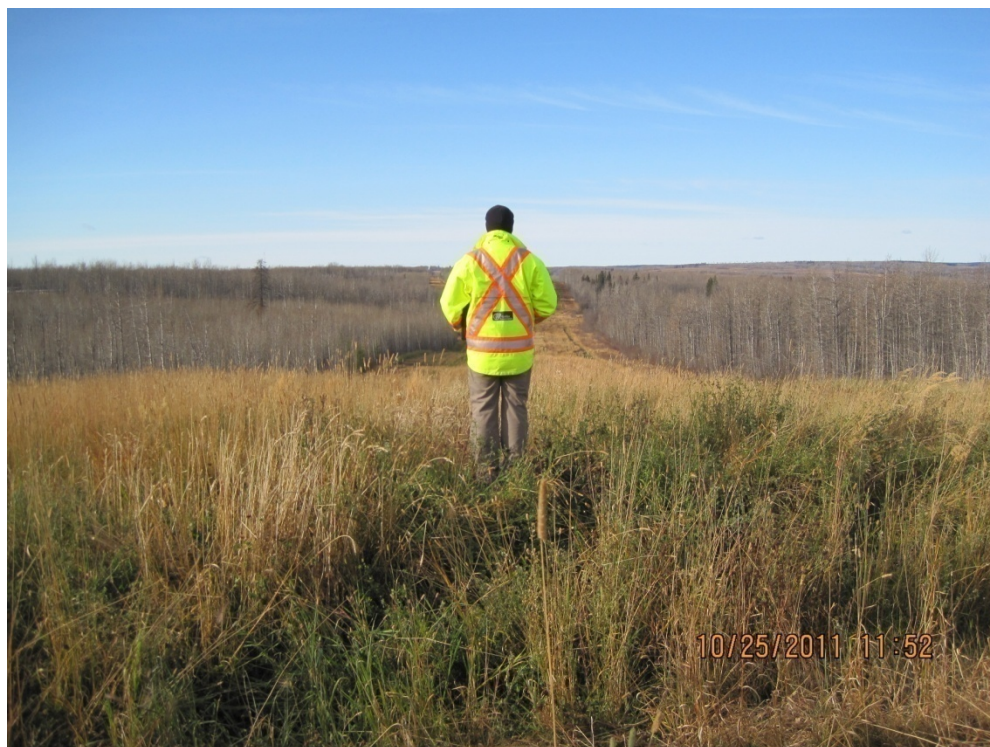
*Photograph 3: Looking west along the ROW from chainage 1+300 showing roach above the pipeline trench.*

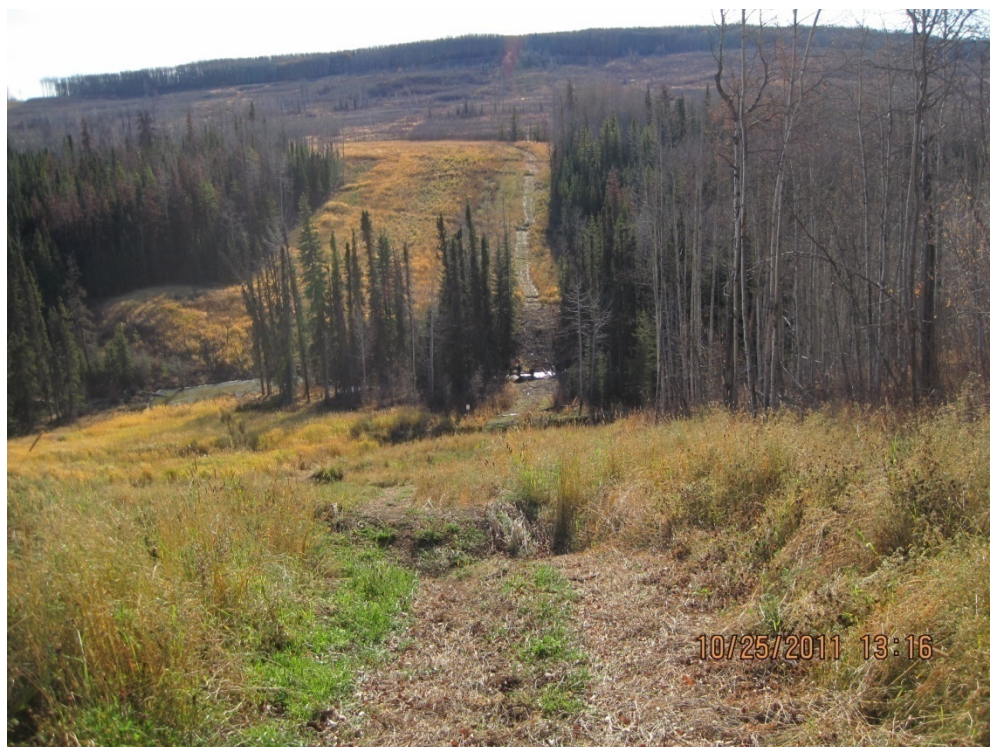
*Photograph 4: Erosion along quad trail (facing south, chainage 2+725).*
