MANITOBA–MINNESOTA TRANSMISSION PROJECT

ENVIRONMENTAL MONITORING PLAN

SHARP-TAILED GROUSE MONITORING FIELD REPORT

Wildlife Resource Consulting Services MB Inc.

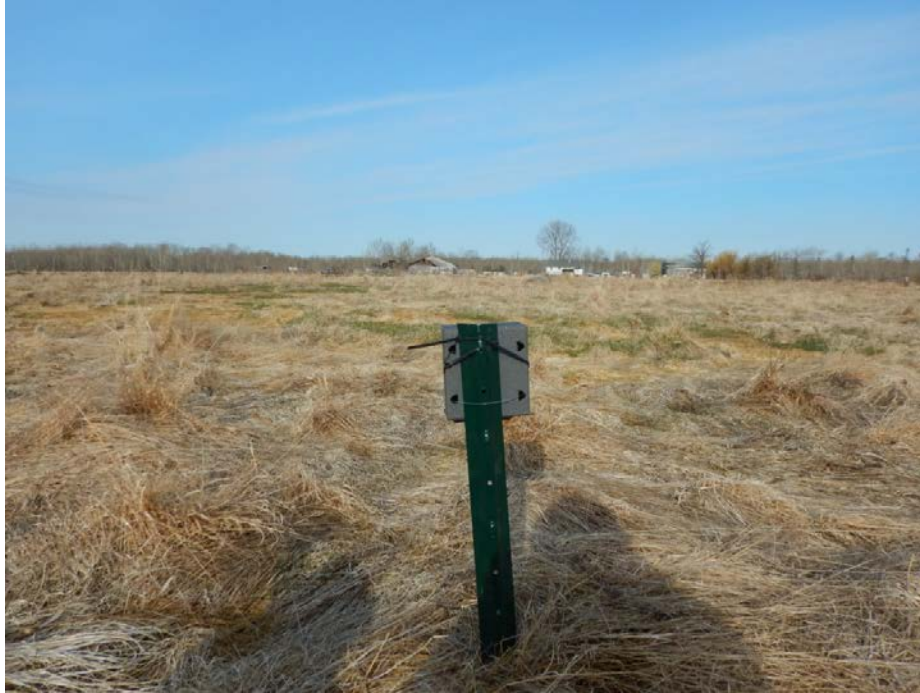
Photo 2: Trail camera at site 290L May 2, 2017

Each lek was revisited one to three days after trail cameras were deployed to ensure the cameras were functional and were capturing sharp-tailed grouse activity. Cameras were moved if necessary, and batteries were checked and replaced as needed. The cameras were removed May 15, 2017. The total number of camera operating days ranged from eight to 14 mornings.
