Re: Westcoast Energy Inc., carrying on business as Spectra Energy Transmission (Westcoast)
Goodrich Extension Re-Injection Pipeline 2015 Reclamation Report
Order XG-W102-08-2010
National Energy Board (Board) File No.: OF-Fac-Gas-W102-2009-07 02

Enclosed for filing with the Board is a reclamation report for the post-construction reclamation activities carried out on the Goodrich Extension Re-Injection Pipeline in 2015. The report is being provided in accordance with a commitment given in response to Informal Information Request No. 2 from the Board dated June 16, 2015 ([A4L1T6](#)).

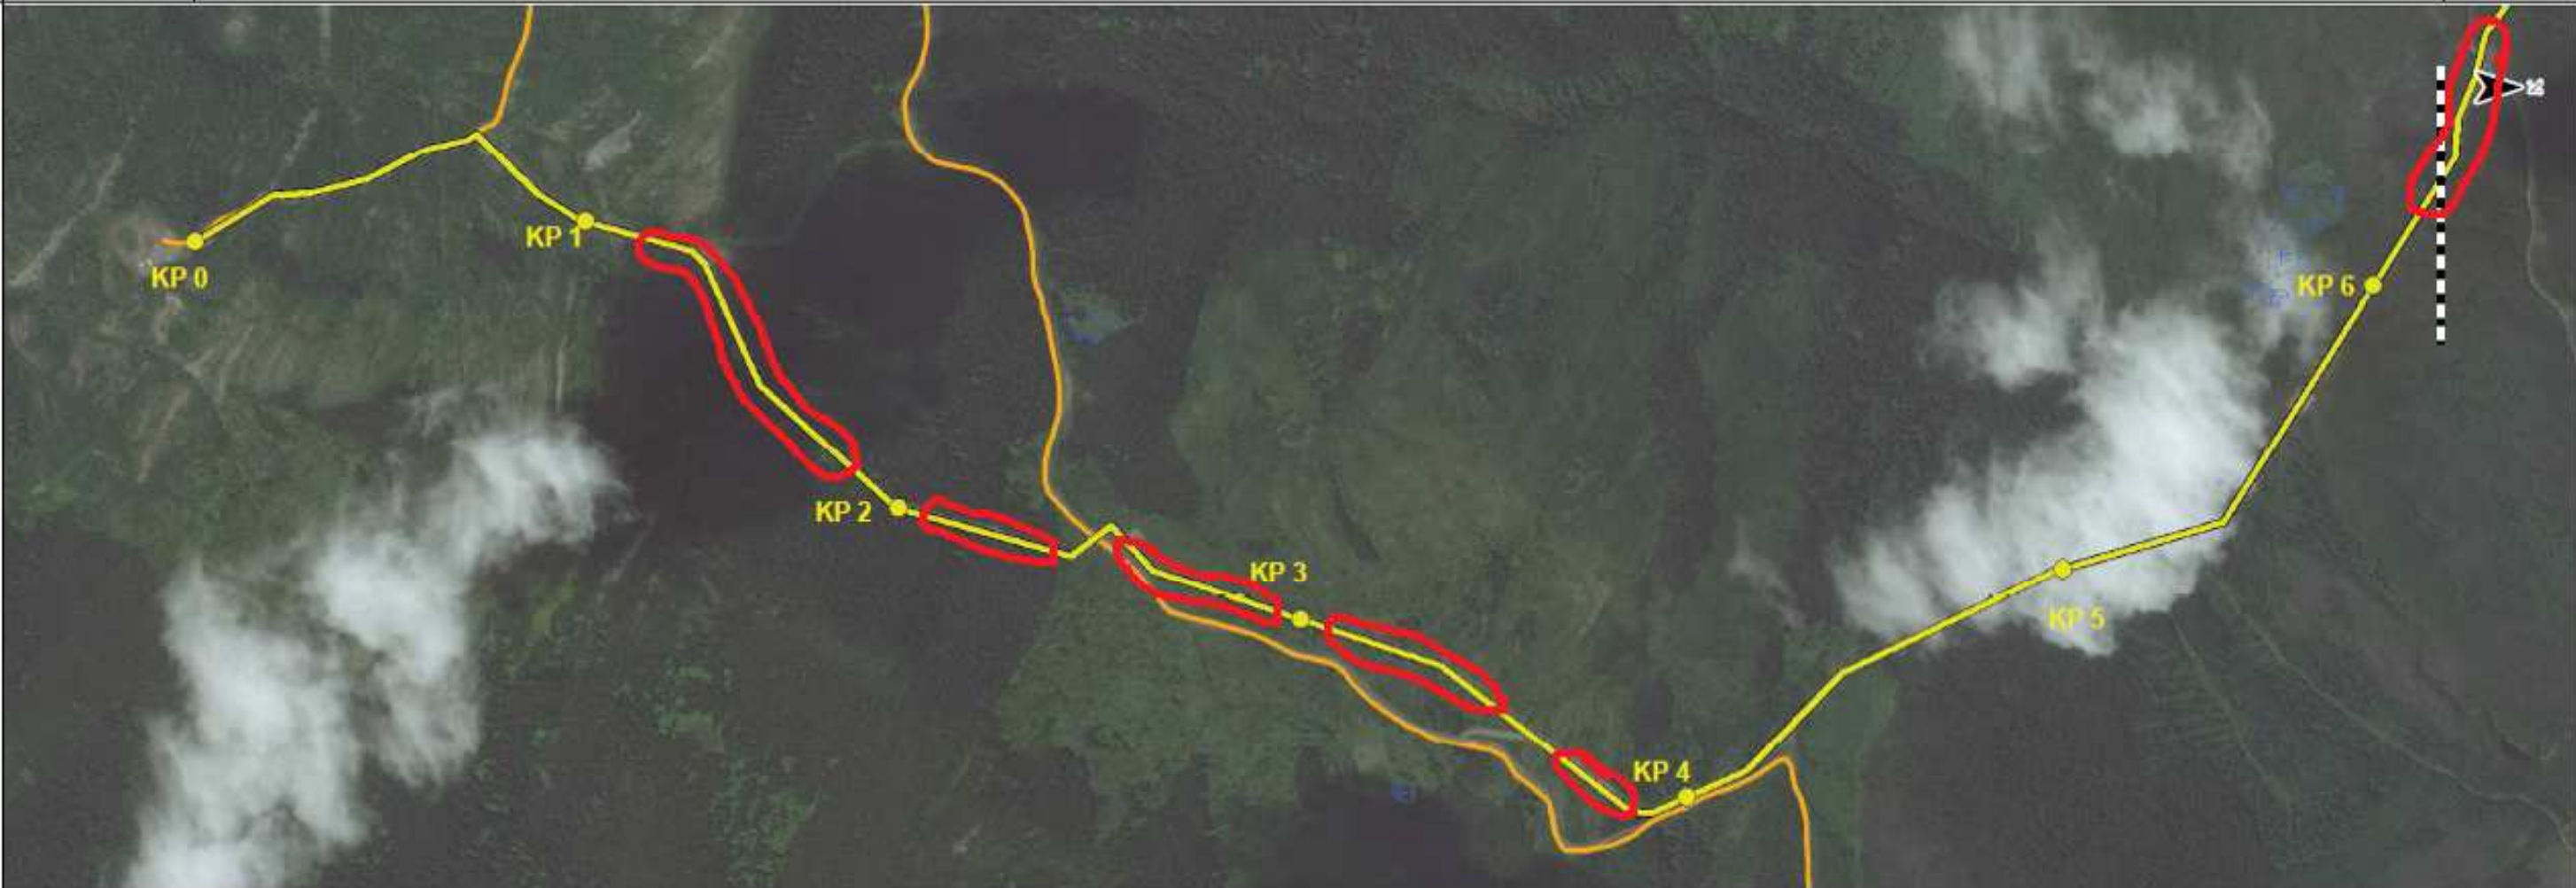
Environmental Setting	Physiography	Northern and Central Plateaus and Mountains					
	Soils	Humo - Ferric Podzol with significant soil inclusion of Dystric Brunisol and LithicSoils	Dominantly Brunisolic Soils-Eutric Brunisol				
	Hydrology	WC #11 – Unnamed Watercourse					
	Fish and Fish Habitat	S3 - Potentially Fish Bearing					
	Biogeoclimitic Zone	Cariboo Engelmann Spruce-Subalpine Fir Wet Cold - ESSF wc 3	Misinchinka Engelmann Spruce-Subalpine Fir Wet Cool - ESSF wk 2				
	Wildlife and Wildlife Habitat	Northern Caribou Range-Burnt Pine Herd					
Environmental Alignment Sheet 11" x 17 Mosaic Scale 1:15,000

Environmental Monitoring Issues Post-Construction	2013	Vegetation Establishment Refuse Vegetation Establishment Vegetation Establishment Vegetation Establishment Vegetation Establishment Erosion					
	2014	Weeds Culvert Vegetation Establishment Culvert and Refuse Vegetation Establishment Erosion Vegetation Establishment Refuse Vegetation Establishment Erosion Sloughing Vegetation Establishment Erosion Vegetation Establishment Rutting
